BELZONA REPAIRS AND PROTECTS GASO TREATER

ID: 5420

Customer Location: Houston, TX, USA
Application Date: November 2012

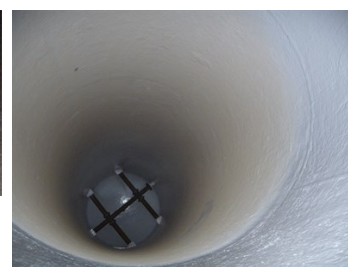
Corrosive process environment used in treating Heavy Gas and Natural Gas caused excessive pitting to vessel walls. Not only did coating have to stand up to this environment it needed to withstand steam out approaching 400F.

- * Vessel exterior ,
- * Vessel floor and wall ,
- * Close up of pitting ,
- * Finished project ,

Application was carried out in accordance with a specific Method Statement developed for this project which included Belzona Know-How System Leaflet TCC-3 for repairing/renewing damaged linings. Belzona 1111 was used for pit filling; Belzona 5892 was applied using a brush as a two coat system in accordance with Belzona Instructions For Use.
