# Belzona Stops Clarifier Leak Externally

ID: 5422

Customer Location: Houston, Texas, USA  
Application Date: June 2014

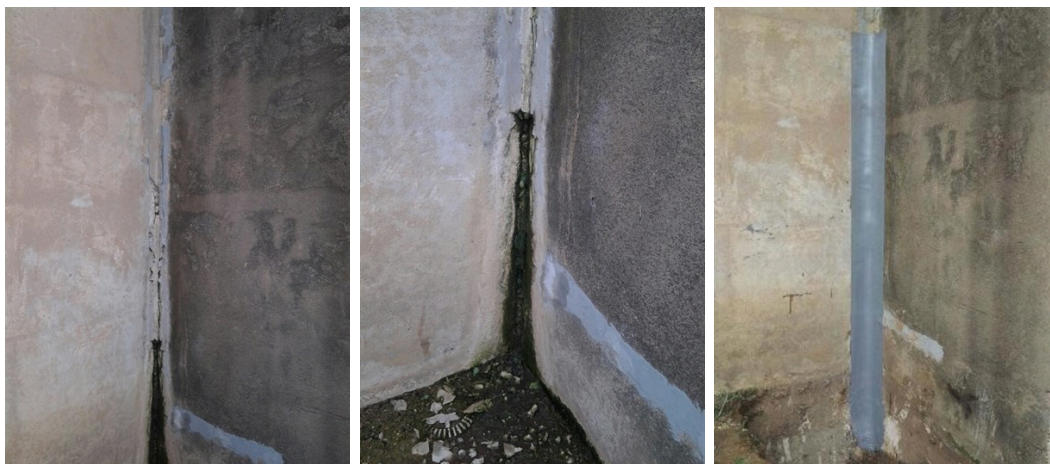
The leak was causing an environmental hazard as well as slippery walkways for pedestrians. The customer could not drain the unit. An external repair was needed to stop the leak.

- \* The application area before repair ,
- \* The application area before the area ,
- \* The area after the application and leak free ,

Leak at clarifier wall

Application was carried out using a modified version of Belzona Know-How System Leaflet VPF-11. Belzona 1291 was used to stop the initial leak, then Belzona 1161 was applied with Belzona 9341 reinforcement cloth over the entire area.

The customer had several failed attempts at the repair with other products, the Belzona solution had the repair complete within hours.
