BELZONA REPAIRS STEEL PIPE ELBOW AT A POWER PLANT

ID: 5423

Industry: Power

Application: SHM-Solids Handling Machinery

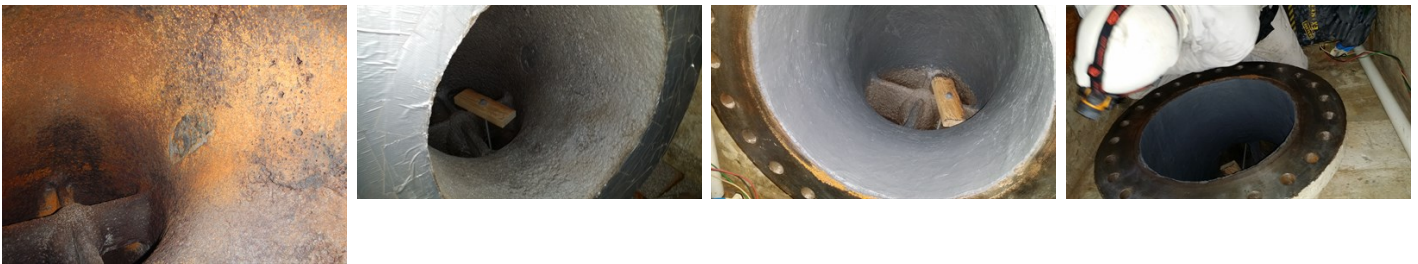
Photograph Descriptions

Very old pipe elbow needed to be replaced due to high corrosive pitting. It was close to having holes through to the concrete foundation of the historic building (power house).

- * 1. Pipe elbow before the application ,
- * 2. Pipe elbow after Sponge-Jet Blasting ,
- * 3. Pipe elbow after application of Belzona 1311 ,
- * 4. Pipe elbow after application of Belzona 1321 ,

Sponge-Jet abrasive grit blasting was used to prepare the metal surface. Application was carried out in accordance with Belzona Know-How System Leaflet SHM-8.

Belzona provided the client with the solution to eliminate the outside environment to being able to affect the steel substrate. Due to time and the elements the pipe elbow was deteriorating. After preparation of the corroded metal surface using Sponge-Jet abrasive grit blasting, Belzona 1311 was applied and Belzona 1321 was then applied in two coats. This created a barrier and a smooth surface, and saved the client costs of having to retrofit a new pipe elbow, foundation alteration of a historic building, environmental challenges, and labor.
