# BELZONA REPAIRS A RUBBER IMPELLER AT A SUGAR MILL

ID: 5424

Industry: Sugar  
Application: SHM-Solids Handling Machinery

Sugar mill pump impeller

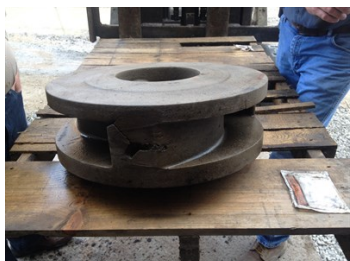
After years of use, impeller had cuts and holes that had to be repaired or impeller be replaced. The mill did not want to buy a new one if the impeller could be repaired.

- \* 1. Impeller before repairs ,
- \* 2. Worst area after degreasing; ready to be roughened up ,
- \* 3. Worst area after Belzona application ,
- \* 4. Finished repaired impeller ready for another grind season. ,
