BELZONA REPAIRS A RUBBER IMPELLER AT A SUGAR MILL

ID: 5424

Industry: Sugar
Application: SHM-Solids Handling Machinery

Sugar mill pump impeller

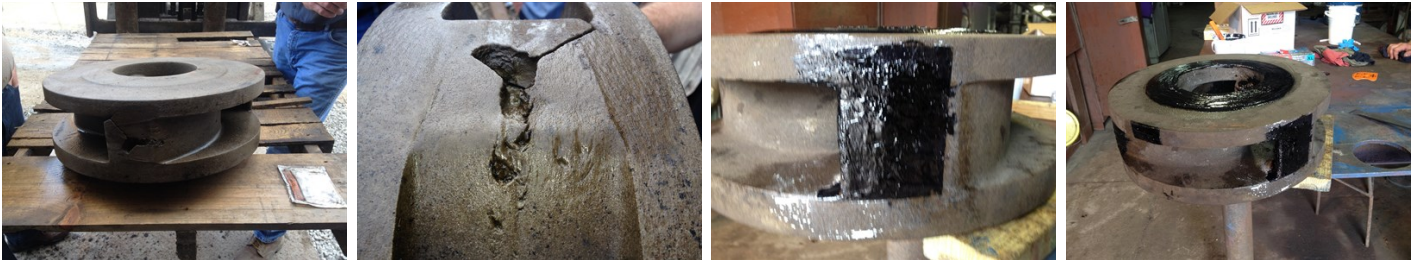
Photograph Descriptions

After years of use, impeller had cuts and holes that had to be repaired or impeller be replaced. The mill did not want to buy a new one if the impeller could be repaired.

- * 1. Impeller before repairs ,
- * 2. Worst area after degreasing; ready to be roughened up ,
- * 3. Worst area after Belzona application ,
- * 4. Finished repaired impeller ready for another grind season. ,

The application was carried out in accordance with Belzona Know-How System Leaflet SHM-11.

Customer had used other Belzona products to successfully lengthen the time between replacement and also improve efficiency of equipment. The impeller was coated for 75% of the cost of a new impeller.
