SHOWER REPAIRED AND PROTECTED WITH BELZONA

ID: 5429

Customer Location: Dredge Boat, South Louisiana, USA
Application Date: May 2014

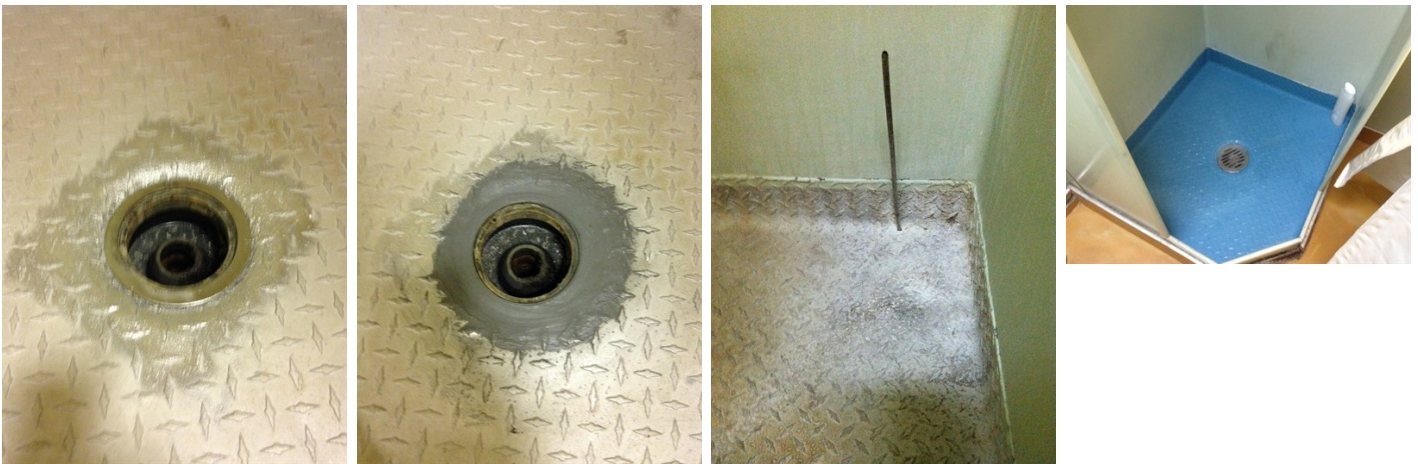
Photograph Descriptions

Crew was using cleaner on shower that was not supposed to be used on aluminum. Cleaner was eroding the metal. Shower floor made of aluminum and drains are brass. Bimetallic corrosion was occurring at drain. So, basically 2 different problems were occurring and destroying the shower floor.

- * 1. Drain prepared for Belzona application ,
- * 2. Belzona metal filled in areas where corrosion was occurring ,
- * 3. Holes had appeared from using the chemical cleaner ,
- * 4. Application completed ,

Application was carried out in accordance with a modified version of Belzona Know-How System Leaflet FPA-1.

Showers are now more aesthetically pleasing plus corrosion issues have been stopped. The only alternative was to replace the

shower floor which would have been very expensive. The Belzona repair per shower is about \$150.00. Cheif Engineer has had great success with Belzona products and felt confident in using Belzona 1341 for the coating.
