# BELZONA REPAIRS A DOCK HOSE BEFORE INSPECTION

Industry: *Marine*  
Application: *SOS-Ships and Offshore Structures*

Customer Location: *Terminal Dock, Louisiana, USA*  
Application Date: *July 2013*

Substrate: *Rubber*  
Products: *\* Belzona 2311 (SR Elastomer) ,*  
*\* Belzona 2911 (Conditioner) ,*

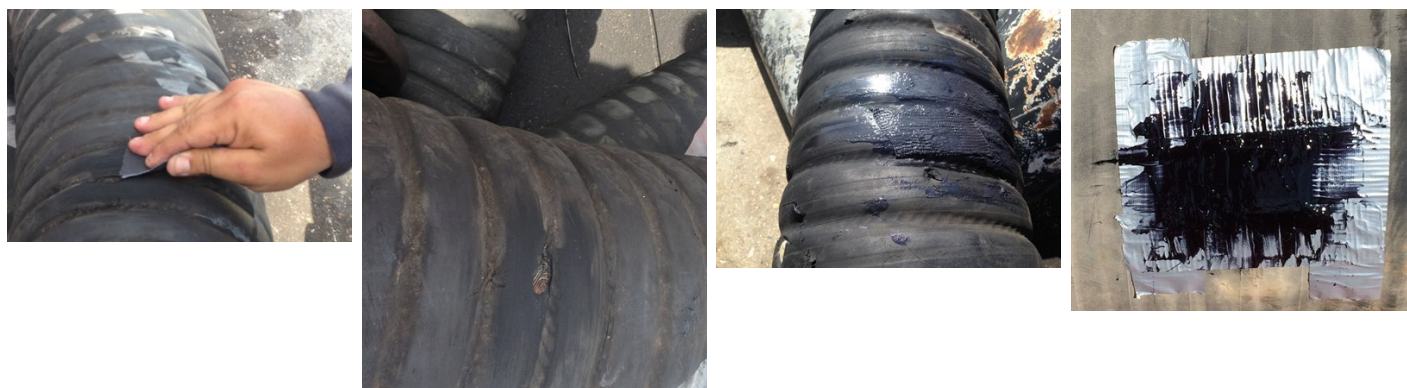
## Photograph Descriptions

*Over the years as the dock hose had been drug around the deck and over shipside, the hose had been cut and gouged.*

- \* 1. Area being prepared for repair. ,
- \* 2. Area after Belzona 2911 applied. ,
- \* 3. Belzona 2311 applied. ,
- \* 4. Finished repair before tape removed. ,

Rubber Dock Hose with cuts.

After proper surface preparation, the application was carried out in accordance with a modified version of Belzona Know-How System Leaflet SOS-12.
