# BELZONA REPAIRS A CONVEYOR BELT

ID: 5432

Industry: *General Industry*  
Application: *SHM-Solids Handling Machinery*

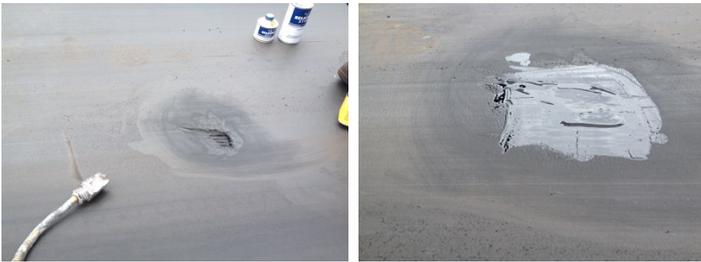
*Conveyor belt had a 2" x 2" piece of rubber missing.*

- \* 1. The area prepared for repair ,
- \* 2. Application is complete ,

Conveyor belt with a piece missing.

The application was carried out in accordance with Belzona Know-How System Leaflet SHM-1. The hole in the belt was filled with Belzona 2311.
