BELZONA PROVIDES A NEW SEAMLESS FLOOR AT A SCHOOL

ID: 5438

Customer Location: School, Edmonds, WA, USA
Application Date: 2014

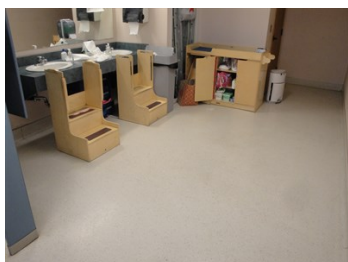
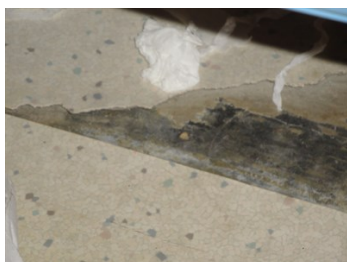
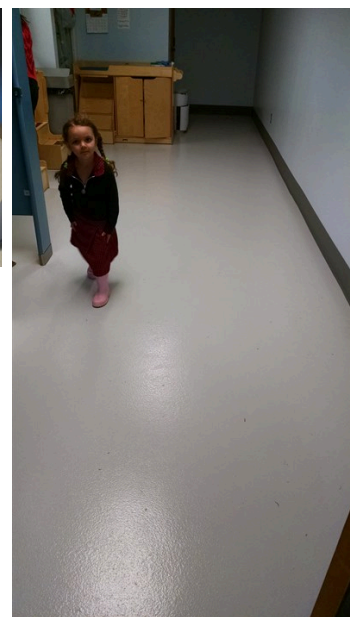
Photograph Descriptions

After twenty years the laminate flooring suffered from age and had become unsanitary. Odor and visible delamination of the laminate was a concern.

- * 1. Laminate failing in several areas ,
- * 2. Showing signs of use ,
- * 3. Seams suspect to hygiene standards ,
- * 4. Happy customer in a healthy & safe environment ,

After proper surface preparation, the application was carried out in accordance with Belzona Know-How System Leaflets FPA-3 and FPA-8.

Belzona provided the client with the solution to eliminate safety and health challenges. The adhesion near the seams was failing and delamination increased tears and created holes, so the removal of the contaminated linoleum flooring was of the essence. After adequate preparation of the concrete, Belzona 5231 was applied in two coats, freshening up and creating a safe and healthy area. The application of Belzona 5231 took place after 6pm and was ready for foot traffic by the next morning.
