BELZONA PROVIDES A NEW SEAMLESS FLOOR AT A SCHOOL

ID: 5438

Industry: Buildings & Structures
Application: FPA-Floor Problem Areas
Substrate: Concrete
Products: * Belzona 5231 (SG Laminate) ,

Customer Location: School, Edmonds, WA, USA
Application Date: 2014

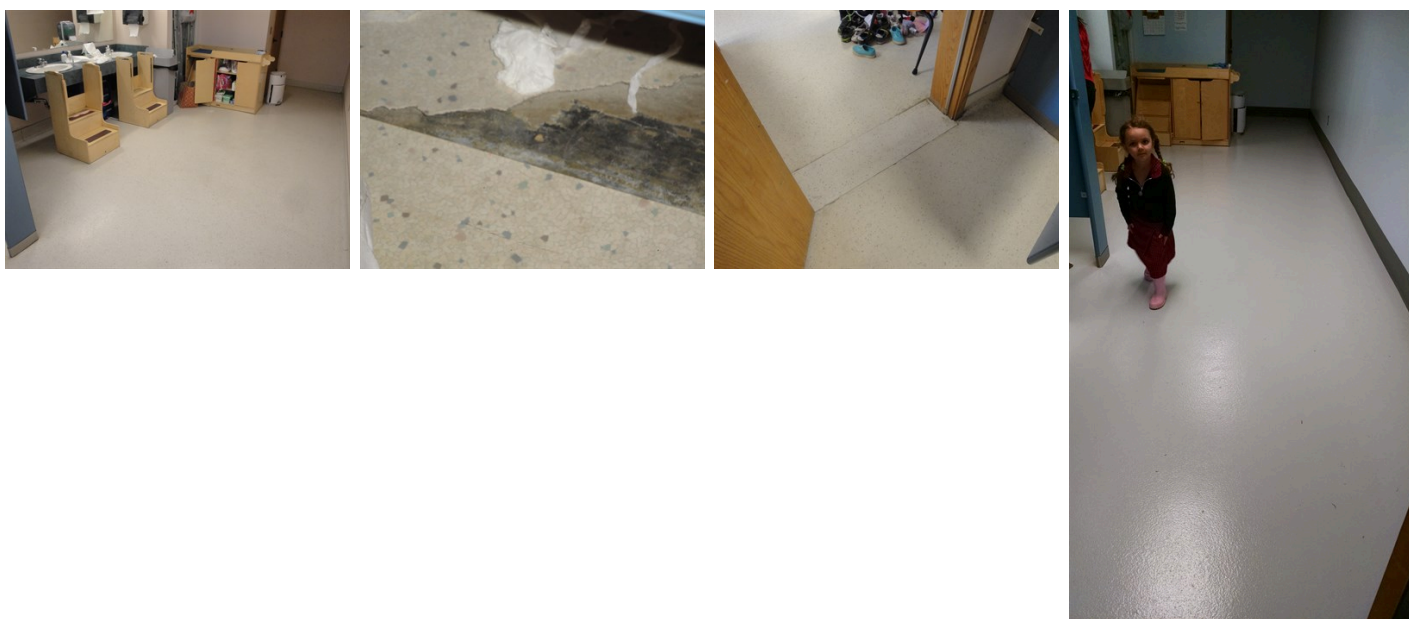
Photograph Descriptions

After twenty years the laminate flooring suffered from age and had become unsanitary. Odor and visible delamination of the laminate was a concern.

- * 1. Laminate failing in several areas ,
- * 2. Showing signs of use ,
- * 3. Seams suspect to hygiene standards ,
- * 4. Happy customer in a healthy & safe environment ,

After proper surface preparation, the application was carried out in accordance with Belzona Know-How System Leaflets FPA-3 and FPA-8.

Belzona provided the client with the solution to eliminate safety and health challenges. The adhesion near the seams was failing and delamination increased tears and created holes, so the removal of the contaminated linoleum flooring was of the essence. After adequate preparation of the concrete, Belzona 5231 was applied in two coats, freshening up and creating a safe and healthy area. The application of Belzona 5231 took place after 6pm and was ready for foot traffic by the next morning.
