BELZONA REBUILDS AND PROTECTS RUDDERS

Industry: *Marine*
Application: *SOS-Ships and Offshore Structures*

Substrate: *Mild steel*
Products: ** Belzona 1311 (Ceramic R Metal) Belzona 1341 (Supermetalgilde) ,*

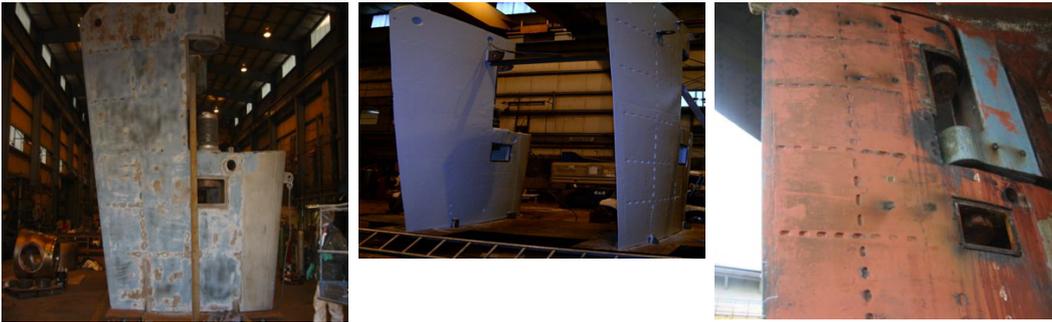
Vessel rudders are subjected to continuous erosion and cavitation attack.

- * 1. Rudders in set up after blasting ready for application. 2. Rudders after application of 2 coats of Belzona 1341 Supermetalgilde. 3. Condition of rudders / rudder horn after 12 years of service with Belzona coating. ,

Application carried out in accordance with Belzona Know-How System Leaflet SOS-1/2
