# BELZONA REBUILDS AND PROTECTS RUDDERS

ID: 5442

Industry: Marine  
Application: SOS-Ships and Offshore Structures  
Customer Location: BC, Canada  
Application Date: December 2004  
Substrate: Mild steel  
Products: \* Belzona 1311 (Ceramic R Metal) Belzona 1341 (Supermetalglide) ,

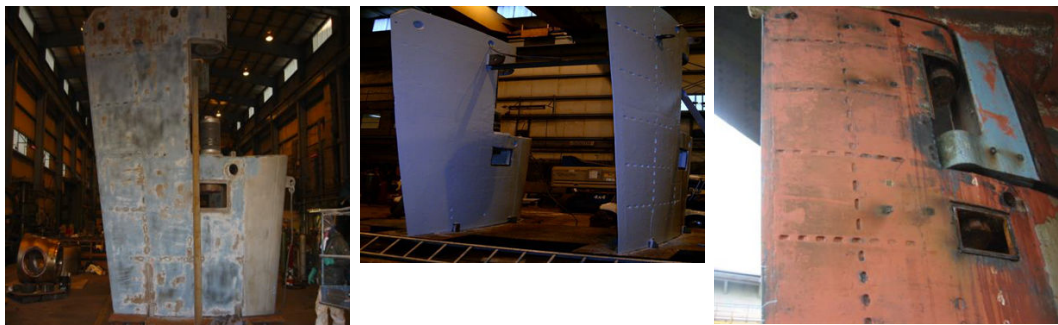
## Photograph Descriptions

Problem  
Vessel rudders are subjected to continuous erosion and cavitation attack.

\* 1. Rudders in set up after blasting ready for application. 2. Rudders after application of 2 coats of Belzona 1341 Supermetalglide. 3. Condition of rudders / rudder horn after 12 years of service with Belzona coating. ,

Application carried out in accordance with Belzona Know-How System Leaflet SOS-1/2
