# BELZONA REBUILT DAMAGE BOW OF RECREATION BOAT

ID: 5444

Industry: *Marine*  
Application: *SOS-Ships and Offshore Structures*

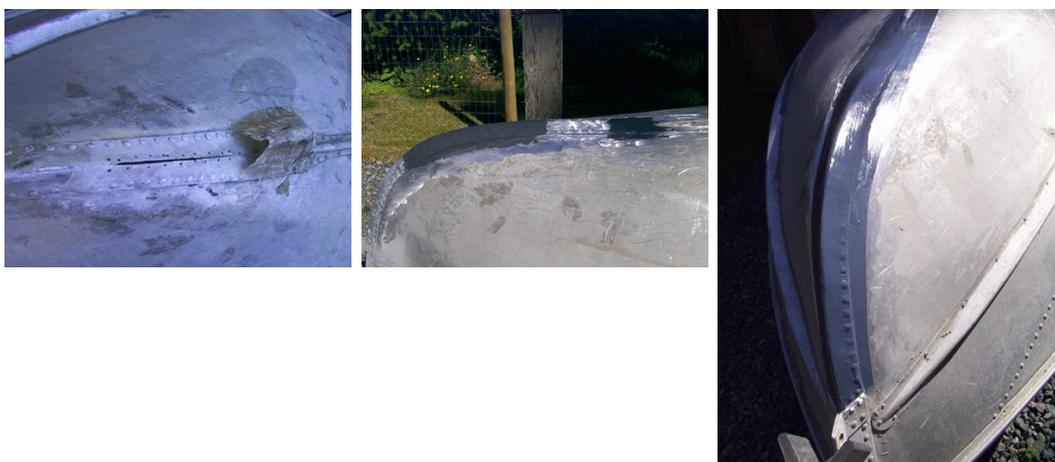
*The rivets on the bow that hold the two halves of the aluminum boat shell together would get worn out from the successive beachings.*

- \* Condition of vessel bow showing failed fiber glass repair. ,
- \* Bow rebuilt to shape with Belzona 1311. ,
- \* Entire repair further protected with 2 coats of Belzona 1321. ,

Rebuilding this area with fiber glass lasted only a single season. The Belzona repair material is heading into its 2nd season unscathed.
