BELZONA REBUILT DAMAGE BOW OF RECREATION BOAT

ID: 5444

Sealing bow's halves on the recreation boat

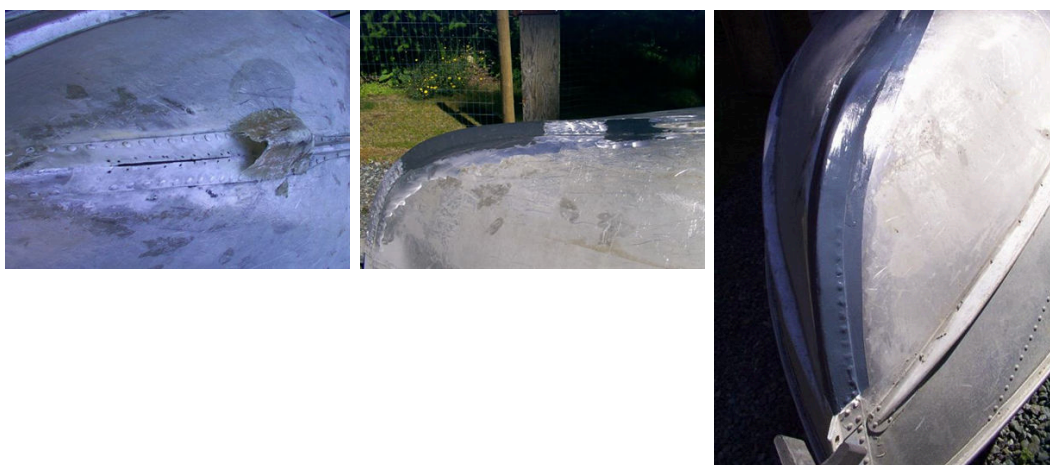
The rivets on the bow that hold the two halves of the aluminum boat shell together would get worn out from the successive beachings.

- * Condition of vessel bow showing failed fiber glass repair. ,
- * Bow rebuilt to shape with Belzona 1311. ,
- * Entire repair further protected with 2 coats of Belzona 1321. ,

Rebuilding this area with fiber glass lasted only a single season. The Belzona repair material is heading into its 2nd season unscathed.
