BELZONA REBUILDS BOW THRUSTER

ID: 5446

Industry: Marine
Application: SOS-Ships and Offshore Structures

Customer Location: BC, Canada
Application Date: 1999

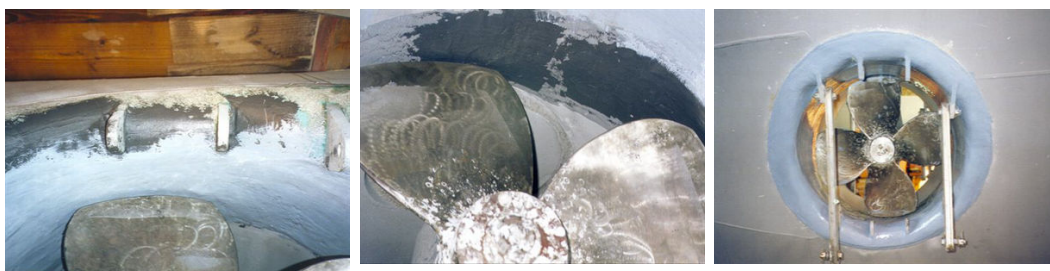
Photograph Descriptions

The fiberglass surround designed to eliminate bimetallic corrosion around the bow thruster insert was not able to protect the area from cavitation attack.

* 1. Fairing in the damaged areas. 2. Fairing in the damaged areas. 3. Entire bow thruster protected with 2 coats of Belzona 1341 Supermetalglide. ,

Application carried out in accordance with Belzona Know-How System Leaflet SOS-1/2

The use of Belzona allowed localized repairs to be executed with a minimal amount of down time.
