BELZONA 1341 SUPERMETALGLIDE PROTECTS RUDDERS

ID: 5449

Application: *SOS-Ships and Offshore Structures*

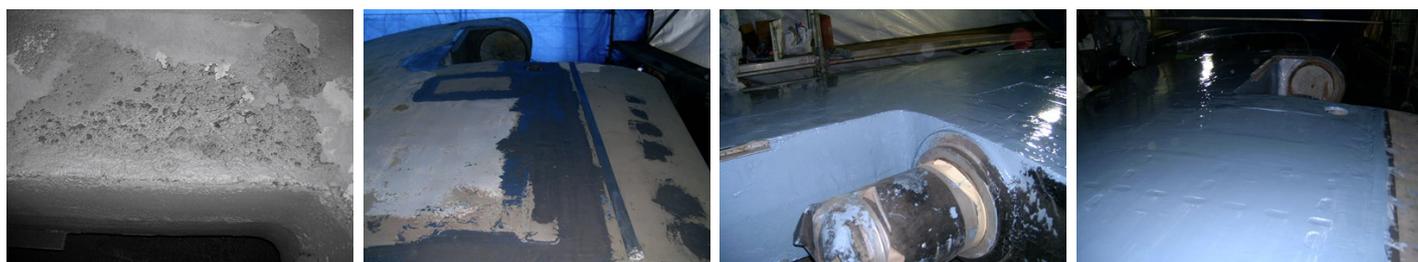
Photograph Descriptions

Rudders were showing sever metal loss in areas where cavitation attack prevalent .

* 1. View of one of the many badly cavitated areas on the two rudders 2. Rebuilding of eroded areas in progress 3. Application of 1st coat of Belzona 1341 in progress 4. Application of 2nd coat of Belzona 1341 completed ,

Application carried out in accordance with Belzona Know-How System Leaflet SOS-1/2

The use of Belzona for these types of repairs eliminates the need to weld with all its associated problems. The rebuild process also reduces the time required to complete a repair of this kind.
