BELZONA 1341 SUPERMETALGLIDE PROTECTS RUDDERS

ID: 5449

Application: SOS-Ships and Offshore Structures

Rudders

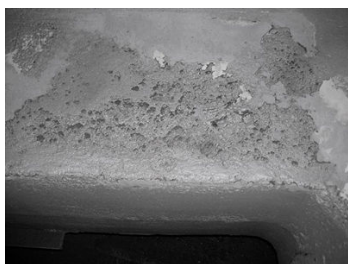
Rudders were showing sever metal loss in areas where cavitation attack prevalent .

* 1. View of one of the many badly cavitated areas on the two rudders 2. Rebuilding of eroded areas in progress 3. Application of 1st coat of Belzona 1341 in progress 4. Application of 2nd coat of Belzona 1341 completed ,

The use of Belzona for these types of repairs eliminates the need to weld with all its associated problems. The rebuild process also reduces the time required to complete a repair of this kind.
