# BELZONA REBUILDS RUDDER SHAFTS

Industry: *Marine*  
Application: *MPT-Mechanical Power Transmission*

Substrate: *Steel*  
Products: *\* Belzona 1111 (Super Metal) ,*

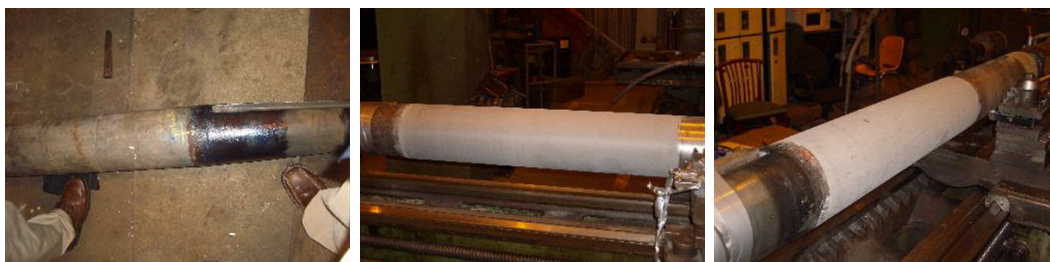
*Tail shafts have suffered from extensive loss of metal.*

- \* Original shaft showing eroded area. ,
- \* Rebuild of shafts completed. ,
- \* Shafts machined and ready for installation. ,

The application was carried out in accordance with Belzona Know-How System Leaflet MPT-1.

Rebuilding the damaged areas with Belzona 1111 allowed the shafts to be rebuilt and machined in less than 2 days.
