BELZONA REBUILDS RUDDER SHAFTS

Industry: *Marine*
Application: *MPT-Mechanical Power Transmission*

Customer Location: *BC, Canada*
Application Date: *November 2006*

Substrate: *Steel*
Products: ** Belzona 1111 (Super Metal) ,*

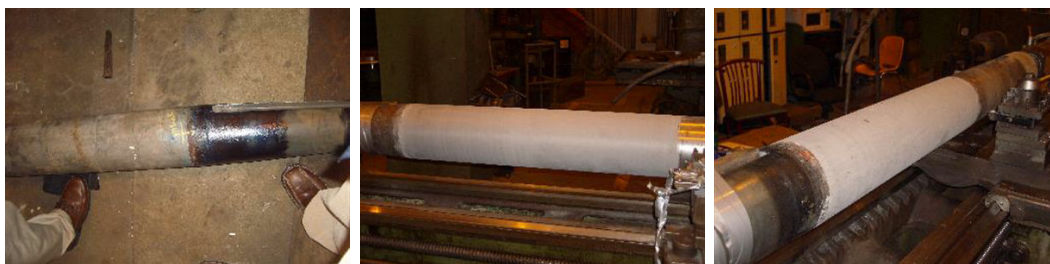
Tail shafts have suffered from extensive loss of metal.

- * Original shaft showing eroded area. ,
- * Rebuild of shafts completed. ,
- * Shafts machined and ready for installation. ,

The application was carried out in accordance with Belzona Know-How System Leaflet MPT-1.

Rebuilding the damaged areas with Belzona 1111 allowed the shafts to be rebuilt and machined in less than 2 days.
