# BELZONA REPAIRS CONCRETE RAMP

ID: 5457

Industry: *Buildings & Structures*  
Application: *FPA-Floor Problem Areas*  
Substrate: *Concrete*  
Products: *\* Belzona 4111 (Magma Quartz) ,*

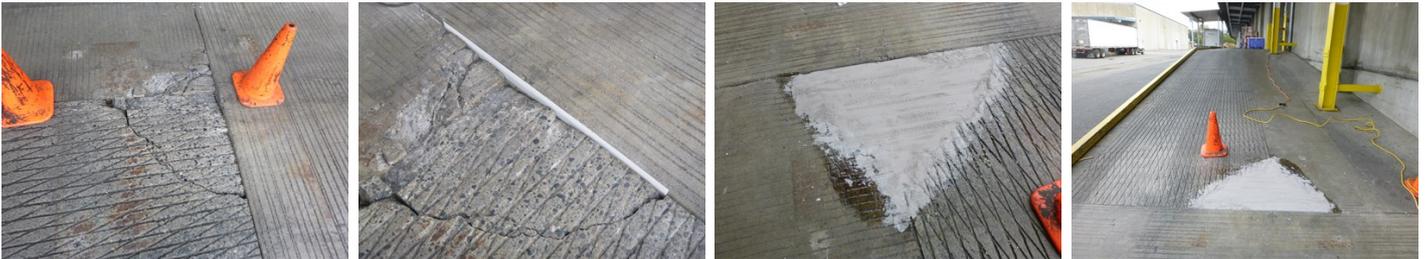
*The foundation under the loading ramp had been undermined causing one concrete panel to crack which made a bump in the road for forklifts, which would then lose loads when hitting this joint.*

- \* Area on forklift ramp for repair ,
- \* Teflon spacer fit into joint to separate adjacent panels ,
- \* Conditioner (seen around edge) and 4111 applied to repair area ,
- \* The ramp repaired from a distance ,

The application was carried in accordance with Belzona Know-How System Leaflet FPA-1. The substrate was thoroughly cleaned and loose material removed. A Teflon spacer was placed into the joint to separate adjacent panels thus avoiding a repeat of cracking that had occurred. The Conditioner was brush applied and Belzona 4111 was hand applied.
