# BELZONA REPAIRS CONCRETE RAMP

ID: 5457

Application: FPA-Floor Problem Areas

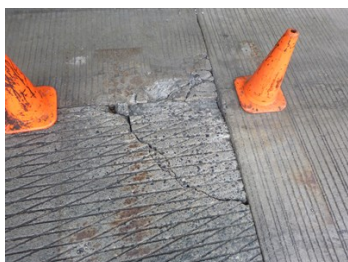
The foundation under the loading ramp had been undermined causing one concrete panel to crack which made a bump in the road for forklifts, which would then lose loads when hitting this joint.

- \* Area on forklift ramp for repair ,
- \* Teflon spacer fit into joint to separate adjacent panels ,
- \* Conditioner (seen around edge) and 4111 applied to repair area ,
- \* The ramp repaired from a distance ,

The application was carried in accordance with Belzona Know-How System Leaflet FPA-1. The substrate was thoroughly cleaned and loose material removed. A Teflon spacer was placed into the joint to separate adjacent panels thus avoiding a repeat of cracking that had occurred. The Conditioner was brush applied and Belzona 4111 was hand applied.
