BELZONA REBUILDS ERODED RUDDER BUSHINGS

ID: 5459

Rudder bushings

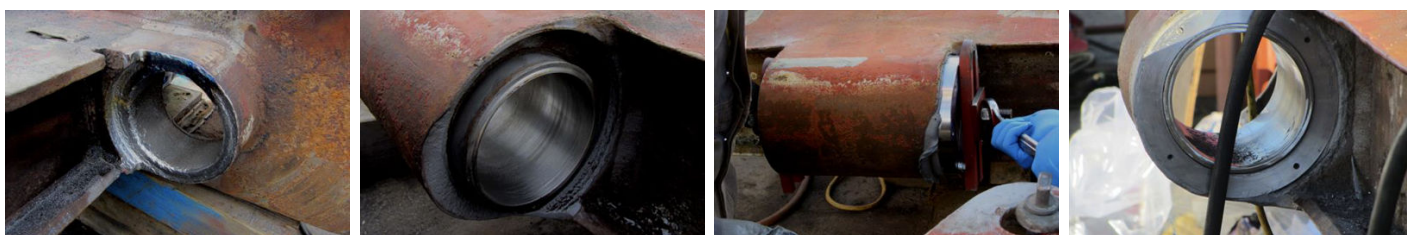
The bushing areas had suffered serious bi-metallic erosion.

- * The eroded bronze bushing removed. ,
- * Bushing fitted for a dry run. ,
- * Belzona 1111 applied and the whole assembly squeezed into place using a purpose made clamp. ,
- * Completed application. ,

The application was carried out in accordance with Belzona Know-How System Leaflet SOS-3.

Using Belzona 1111 saved many hours of dry docking time. It also reduced the possibility of bi-metallic corrosion from recurring.
