# BELZONA STOPS TANK LEAK AT NUCLEAR POWER PLANT

ID: 5460

Industry: Power  
Application: FBC-Fans, Blowers and Compressors

Customer Location: Northern Texas, USA  
Application Date: October 2014

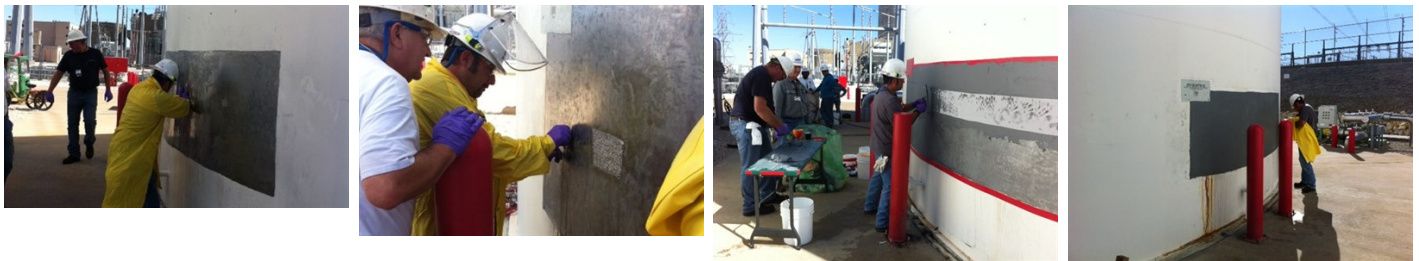
Pinholes developed in the tank that is used for emergency backup water for refueling. After testing it was discovered that a large area of the 3/16" steel sidewall was only .050 thick.

- \* Plugging active leak ,
- \* Patching over Belzona 1291 ,
- \* Applying Belzona 1111 with Belzona 9431 ,
- \* Completed application ,

Pinhole Leaks and Thin Sidewall.

The paint was removed and the surface was steel grit blasted to a 3 mil profile. Two of the pinholes were 1/2" in diameter and bolts with flat washers were coated with Belzona 1291 and placed into the holes. The third hole was 1/8" diameter and a sheet metal screw with a flat washer was coated with Belzona 1291 and placed into the hole. The first layer of Belzona 1111 was applied about 1/8" thick. Then Belzona 9431 was applied with the second coat of Belzona 1111.
