# ROOF PROTECTION TO RESERVOIR VALVE TOWER

ID: 5461

Industry: *Commercial Facilities* Customer Location: *Blackburn, UK*  
Application: *RPA-Roof Problem Areas* Application Date: *June 2014*  
Substrate: *Concrete*  
Products: *\* Belzona 4131 (Magma Screed) Belzona 3131 (WG Membrane),*

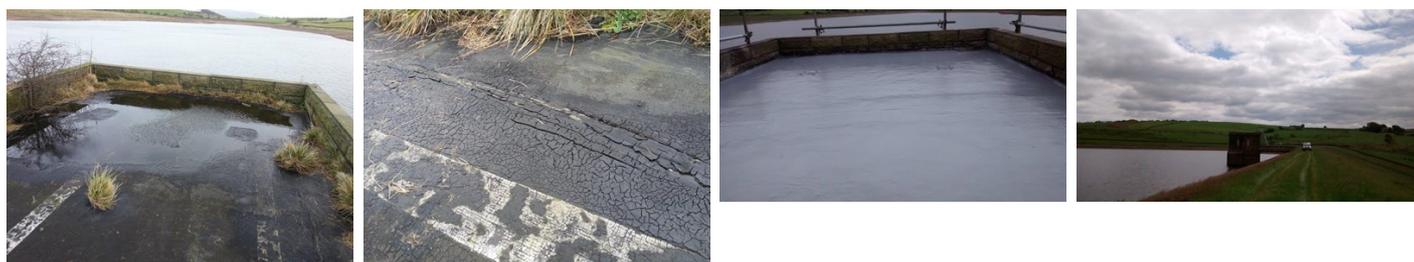
## Photograph Descriptions

*Damage to asphalt coated roof causing water ingress resulting in spalling concrete underneath. There was also severe plant growth.*

\* 1. Standing water causing damage 2. Damage to substrate 3. Completed Repair 4. Isolated Location ,

The application was carried out in accordance with FPA-1, RPA-1 and RPA-6. All of the damaged asphalt and plant growth was removed and the damaged concrete was rebuilt with Belzona 4131 . Belzona 3131 was subsequently applied to the entire area to prevent further water ingress.
