Belzona Floating Roof Repair

ID: 547

Customer Location: Oil refinery, Egypt
Application Date: December 2004

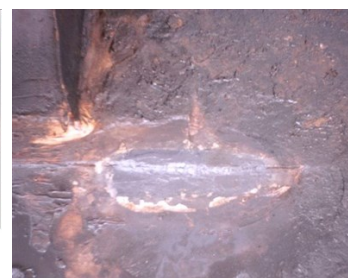
Crude oil leakage through welding seams in the tanks floating roof.

- * General view of the crude oil tank ,
- * The contaminated area of the floating roof ,
- * Cleaning the surface ,
- * Leakage stopped (shown) and in other locations ,

Belzona® 1291 was used to stop the active leak quickly. The flexibility and quick cure of Belzona® 2311 makes it the ideal choice for these types of applications. The Belzona will not crack from the movement of the roof up and down.
