BELZONA RESTORES FLOTATION UNIT AT BIOMASS PLANT

ID: 5470

Dissolved Air Flotation (DAF) Unit in Biomass Plant

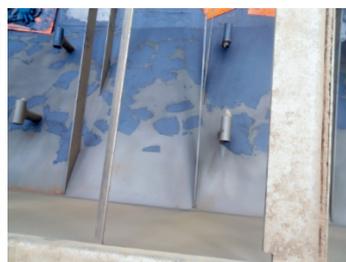
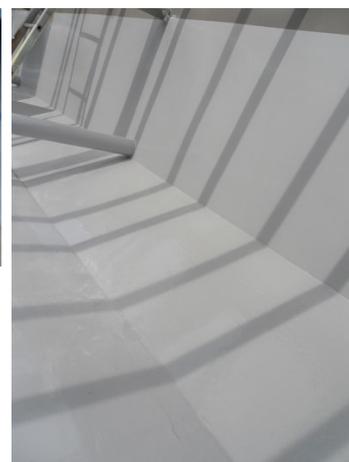
Severe pitting corrosion to the stainless steel unit caused by Ferric Chloride.

- * DAF unit ,
- * Pitting Corrosion ,
- * Plate bonding ,
- * Completed Application ,

The application was carried out in accordance with TCC-1 and TCC-3. Belzona 1111 was used to rebuild the pitting damage. In deeply pitted areas doubler plates were bonded into place. Afterwards the full tank was lined with Belzona 5892.
