BELZONA REBUILDS SPIRAL CASING OF A FRANCIS TURBINE

ID: 5471

Customer Location: Hydropower Plant, France
Application Date: February 2001

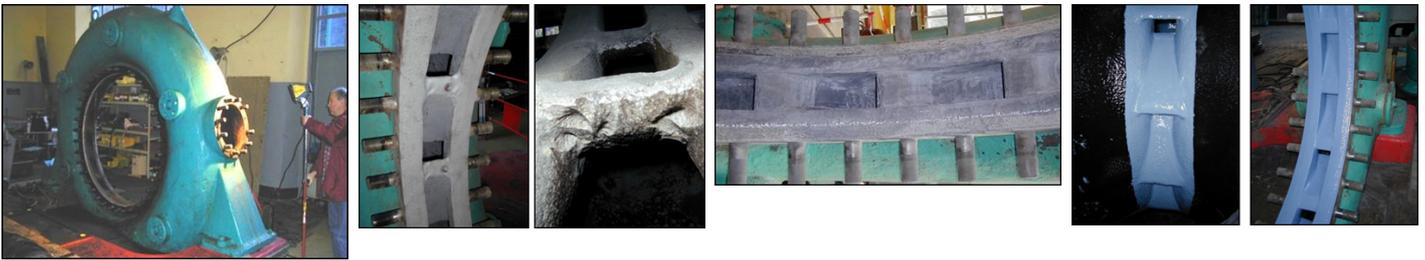
Photograph Descriptions

Corrosion, erosion and cavitation of the casing leading to vibrations and loss of efficiency.

- * Pump casing ,
- * After grit-blasting ,
- * Casing rebuilt with Belzona 1311 ,
- * Completed repair with Belzona 1341 and Belzona 5811 ,

The casing was rebuilt with Belzona 1311 in accordance with Belzona Know-How System Leaflet PDP-6 and then protected with Belzona 1341 where the turbine fits. Then, Belzona 5811 was applied on the other parts.

The power group has recovered its full efficiency and long-term protection was provided to the casing.
