BELZONA REPAIRS AND PROTECTS BULB GENERATOR SET

ID: 5472

Customer Location: Hydropower Plant - France
Application Date: March 2001

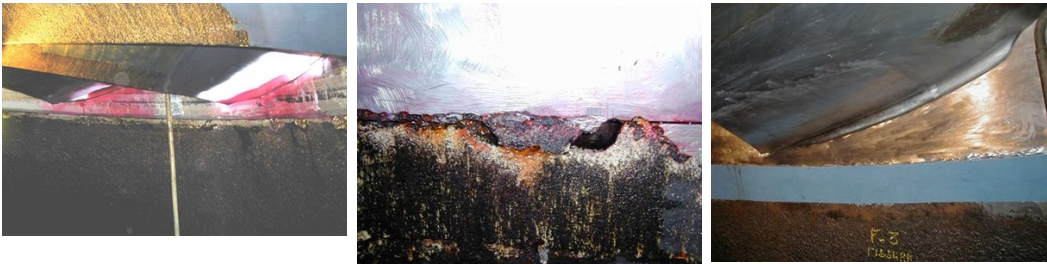
Photograph Descriptions

Important infiltration and corrosion between stainless steel jacket and turbine housing.

- * General view of the housing ,
- * Junction between steel and stainless steel ,
- * Completed repair and protection ,

The damaged junction was repaired with Belzona 1111 and protected with Belzona 1341. The application was completed by the customer.
