BELZONA PROTECTS CYCLONE

ID: 5473

Industry: *General Industry*
Application: *TCC-Tanks and Chemical Containment Areas*
Substrate: *Steel*
Products: ** Belzona 1311 (Ceramic R-Metal) ,
* Belzona 1321 (Ceramic S-Metal) ,*

Customer Location: *France*
Application Date: *August 2004*

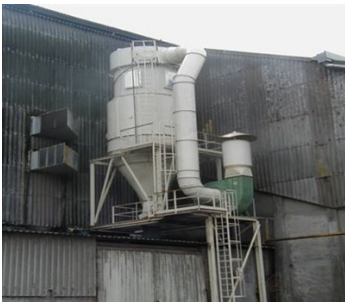
Abrasion inside the cyclone and through-wall damages caused by corncobs.

- * Cyclone to be repaired ,
- * Presence of holes due to abrasion ,
- * Repair with Belzona 1311 and protection with Belzona 1321 ,
