# BELZONA PROTECTS CYCLONE

ID: 5473

**Industry:** *General Industry*  
**Application:** *TCC-Tanks and Chemical Containment Areas*  
**Substrate:** *Steel*  
**Products:** *\* Belzona 1311 (Ceramic R-Metal) ,  
\* Belzona 1321 (Ceramic S-Metal) ,*

**Customer Location:** *France*  
**Application Date:** *August 2004*

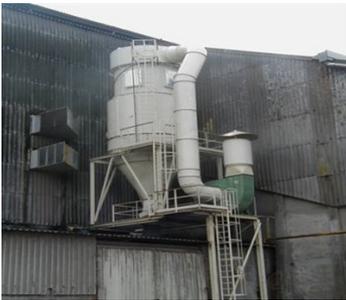
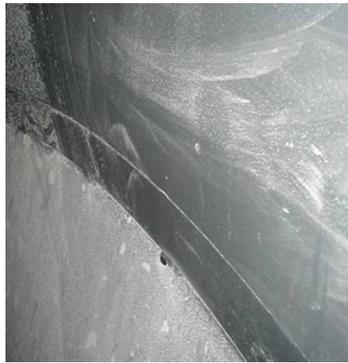
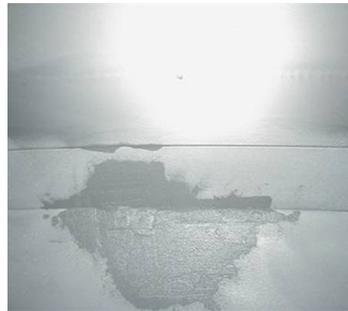
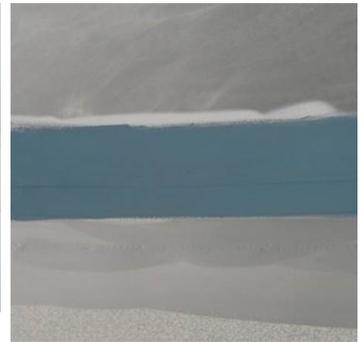
*Abrasion inside the cyclone and through-wall damages caused by corncobs.*

- \* Cyclone to be repaired ,
- \* Presence of holes due to abrasion ,
- \* Repair with Belzona 1311 and protection with Belzona 1321 ,

The application was carried out with cold bonding of stainless steel plates with Belzona 1311, where abrasion protection was important. Belzona 1321 was applied to protect 15cm of all the circumference of the cyclone.
