BELZONA PROTECTS BUFFER STONE WITH INTERNAL COATING

ID: 5474

Customer Location: Refinery, France
Application Date: October 2013

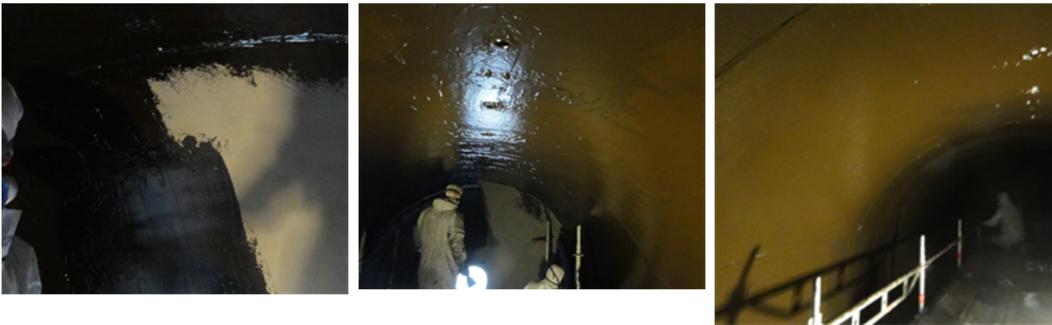
Photograph Descriptions

- * Application on grit-blasted substrate ,
- * Completing the application on the top part of the tank ,
- * Inspecting the thickness of the coating ,

Buffer store with a diameter of 3m and length of 11m, transporting crude oil.

The application was carried out during a shutdown of the refinery. The entire application was completed in a one coat system.
