# Propeller blades cavitation protection

ID: 5485

Industry: *Marine*  
Application: *SOS-Ships and Offshore Structures*

Customer Location: *Croatia*  
Application Date: *March, 2014*

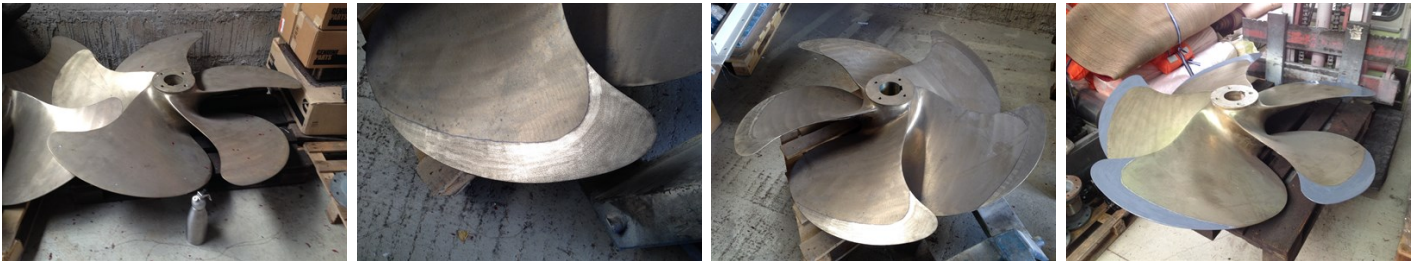
## Photograph Descriptions

*Cavitation on older propeller blades in service demanded protection of new propeller blades.*

- \* Propeller ,
- \* Blade ,
- \* Surface preparation ,
- \* Belzona 1321 applied ,

The application was carried out in accordance with Belzona Know-How System Leaflet SOS-2. Blades were prepared to recommended profile roughness, degreased and coated with two layers of Belzona 1321.

Previous two propellers with the same design had cavitation and were in service. The new ones were protected with Belzona 1321 and put into service. Satisfied customer ordered repair and protection of old propellers with Belzona 1311 and Belzona 1321.
