# Belzona Saves Significant Downtime for Cement Plant

Industry: *Cement*  
Application: *MPT-Mechanical Power Transmission*

Customer Location: *Cement plant - United Arab Emirates*  
Application Date: *May 2005*

Crusher shaft

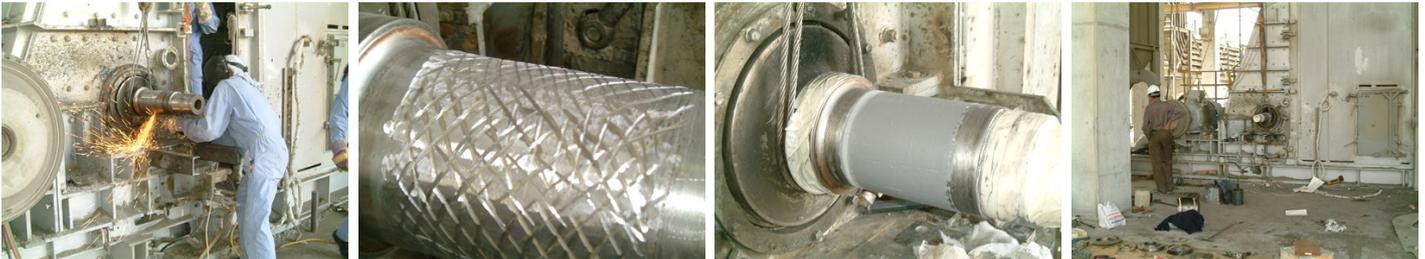
*Bearing area of the 155mm shaft was down due to bearing failure, causing the entire operation to shut down.*

- \* Surface preparation in progress ,
- \* Prepared surface, ready for Belzona to be applied ,
- \* Completed application ,
- \* General view of crusher shaft in operation after the application ,

Application was carried out in accordance with Belzona Know-How System Leaflet MPT-1 and MPT-2.

An alternative method would be to weld and grind the shaft, but this is not possible in situ. Removal of the shaft from the equipment would require over 100 hours of downtime as no spare part was available. With Belzona, this customer was back up and running in hours, not days, saving significant amounts of money from lost production and downtime.
