# BELZONA RESTORES DAMAGED FLOOR IN PAPER PLANT

**Industry:** Pulp & Paper  
**Application:** FPA-Floor Problem Areas  
**Substrate:** Concrete  
**Products:** \* Belzona 4111 (Magma-Quartz) ,  
\* Belzona 4151 (Magma-Quartz Resin) ,  
\* Belzona 4181 (AHR Magma-Quartz) ,

**Customer Location:** Pulp and Paper plant, Leningrad, Russia  
**Application Date:** September, 2009

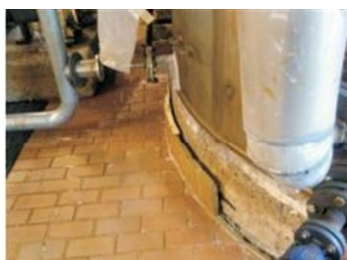
Chemicals had penetrated through the tiled surface leading to rapid degradation of the underlying concrete.

- \* 1. Damaged tile flooring ,
- \* 2. Removal of the old damaged substrate ,
- \* 3. Restoration of the concrete floor base ,
- \* 4. Protecting the floor from the chemicals ,

Tile floor damaged by chemicals including acids and alkalis.
