BELZONA RESTORES DAMAGED FLOOR IN PAPER PLANT

ID: 5508

Customer Location: Pulp and Paper plant, Leningrad, Russia
Application Date: September, 2009

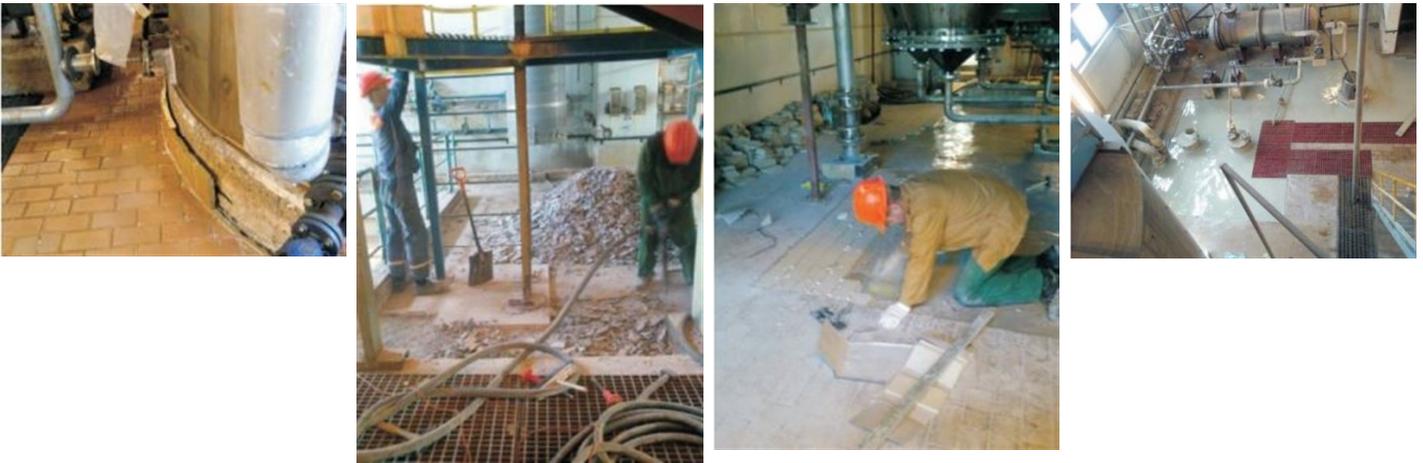
Photograph Descriptions

Chemicals had penetrated through the tiled surface leading to rapid degradation of the underlying concrete.

- * 1. Damaged tile flooring ,
- * 2. Removal of the old damaged substrate ,
- * 3. Restoration of the concrete floor base ,
- * 4. Protecting the floor from the chemicals ,

Tile floor damaged by chemicals including acids and alkalis.

The application was carried out in accordance with Belzona System leaflets FPA-1, 2 & 3. After removing existing tiles the underlying concrete was rebuilt before re-bonding and grouting acid resistant tiles.
