BELZONA REPAIRS VACUUM PUMP

ID: 5509

Liquid ring vacuum pump.

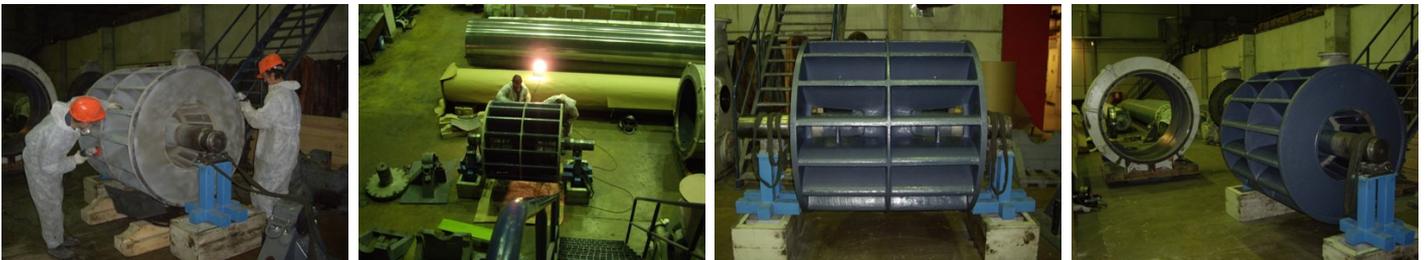
Pump casing, impeller and end plates damaged by erosion and corrosion as a result of handling medium contaminating the water seal, leading to a rapid loss in efficiency.

- * Surface preparation of pump impeller ,
- * Repair of the damaged pump rotor in progress ,
- * Close up view of restored side of the pump ,
- * Completed repair of the pump rotor and casing ,

The application was carried out in accordance with Belzona Know-How System Leaflets PDP-5 and PDP-6. The profiles were restored with Belzona 1311 before coating with Belzona 1321 to provide overall erosion-corrosion protection.
