# BELZONA REPAIRS DRIER DRUM AT SUGAR FACTORY

ID: 5512

Customer Location: *Sugar Factory, Ukraine*  
Application Date: *August 2013*

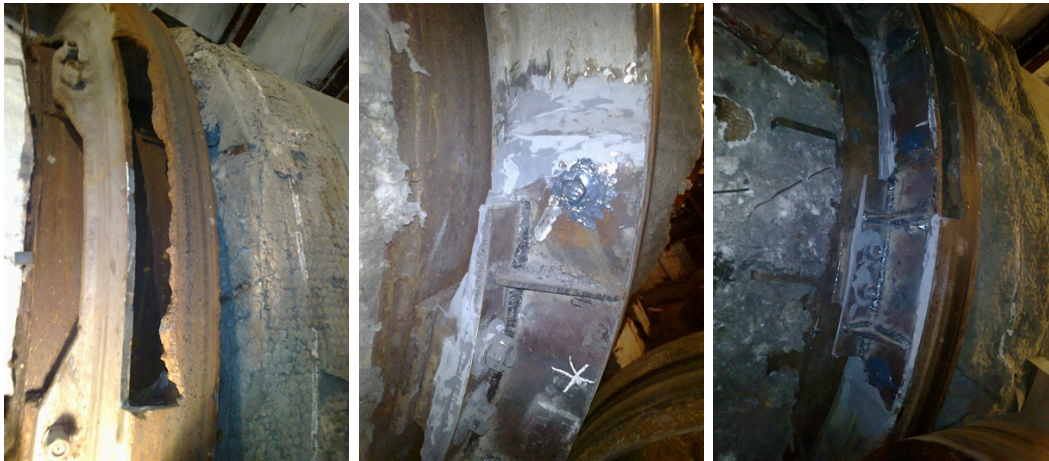
*Corrosion and cracking had caused deterioration to the outer rim surface of the drier.*

- \* Deteriorated metal rim of the drier drum ,
- \* A metal plate fixed onto the side part of the rim using bolts and Belzona ,
- \* Completed repair showing bonded metal plate and Belzona 1111 ,

Damaged outer rim of the drier drum

The application was carried out in accordance with Belzona Know-How System Leaflet ENC-1. A metal doubler plate was bonded using Belzona 1321 for additional strength.
