BELZONA REPAIRS DRIER DRUM AT SUGAR FACTORY

ID: 5512

Customer Location: *Sugar Factory, Ukraine*
Application Date: *August 2013*

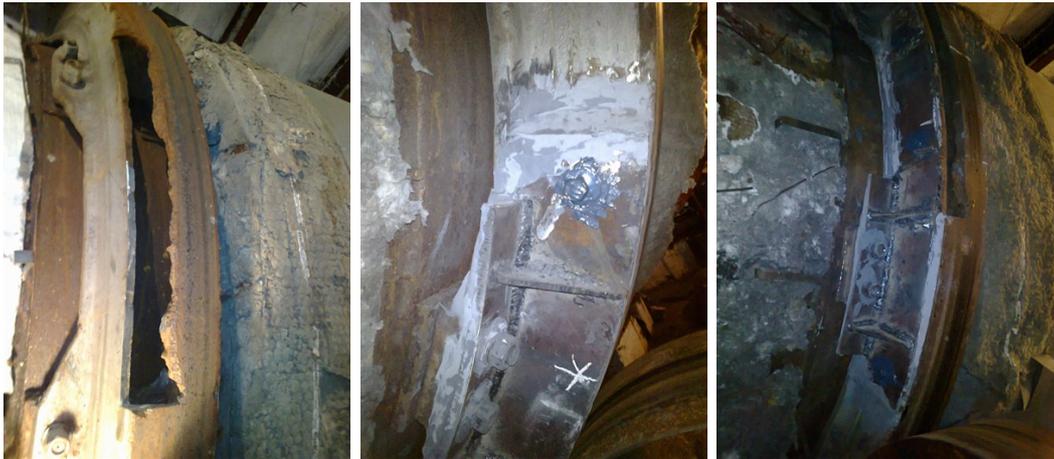
Corrosion and cracking had caused deterioration to the outer rim surface of the drier.

- * Deteriorated metal rim of the drier drum ,
- * A metal plate fixed onto the side part of the rim using bolts and Belzona ,
- * Completed repair showing bonded metal plate and Belzona 1111 ,

Damaged outer rim of the drier drum

The application was carried out in accordance with Belzona Know-How System Leaflet ENC-1. A metal doubler plate was bonded using Belzona 1321 for additional strength.
