# BELZONA FLANGE FACE FORMING ON 4" 150psi FLANGES

ID: 5516

Customer Location: Oil Major, North Sea, UK  
Application Date: November 2014

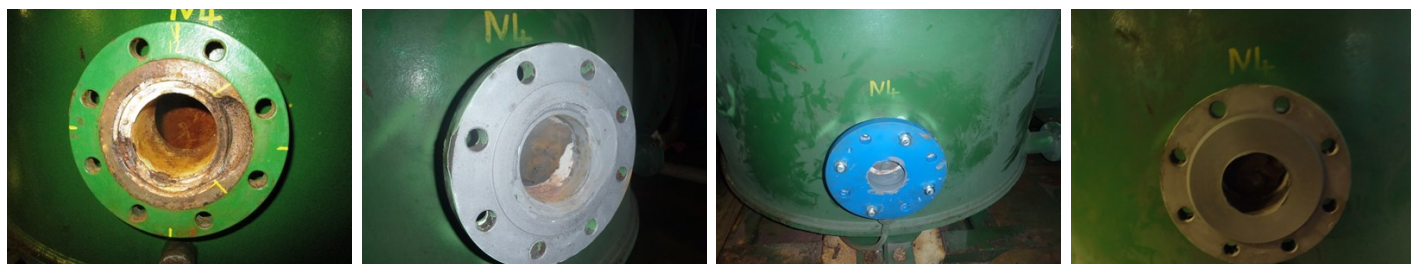
## Photograph Descriptions

Existing coating had failed leading to corrosion of the vessel internals and severe loss of metal on the adjacent flanges.

\* 1. Damaged flange face 2. Flange face after grit blasting and deep pitting roughly infilled with Belzona 1111 3. Belzona flange former in place 4. Completed application after removing former ,

Application was carried out in accordance with Belzona Know-How System Leaflet VPF-17 using the Belzona flange face forming kit.

Client was unable to use hot work and had restricted time. Application was carried out over a weekend and the entire solution, from first notification was completed in less than a week. A number of flanges were reformed using the Belzona re-usable formers. The vessel was returned to service with minimum disruption to the production cycle.
