# BELZONA FORMS 24" FLAT FACE FLANGE

ID: 5517

Customer Location: Oil Major, North Sea, UK  
Application Date: November 2014

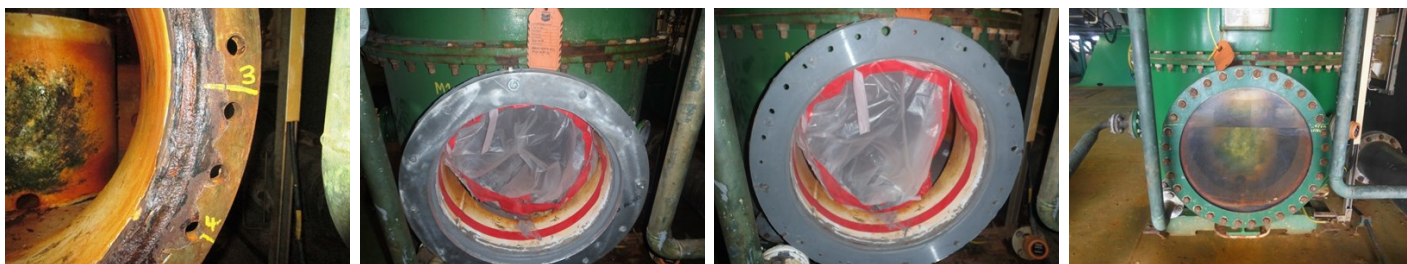
## Photograph Descriptions

Existing coating had failed leading to corrosion of the vessel internals and severe loss of metal on the adjacent flanges. This 24 inch flange was for the Perspex sight port.

\* 1. The damaged flange face. Note damage to internal lining 2. Aluminium former in place 3. Former removed showing reformed flange face with Belzona 1111 4. flange re-assembled with Perspex window in place ,

Application was carried out in accordance with Belzona Know-How System Leaflet VPF-13. An aluminium former was fabricated. This was accurately positioned using shims to allow accurate reconstruction of the flange face with Belzona 1111 to be completed.

Client was unable to use hot work and had restricted time. Application was carried out over a weekend and the entire solution, from first notification, including former fabrication, was completed in less than a week. A number of other flanges were reformed using the Belzona re-usable formers. The vessel was returned to service with minimum disruption to the production cycle.
