Belzona Repairs to High Speed Vessel

Industry: *Marine*
Application: *SOS-Ships and Offshore Structures*

Customer Location: *Ship repair company - Egypt*
Application Date: *May 2002*

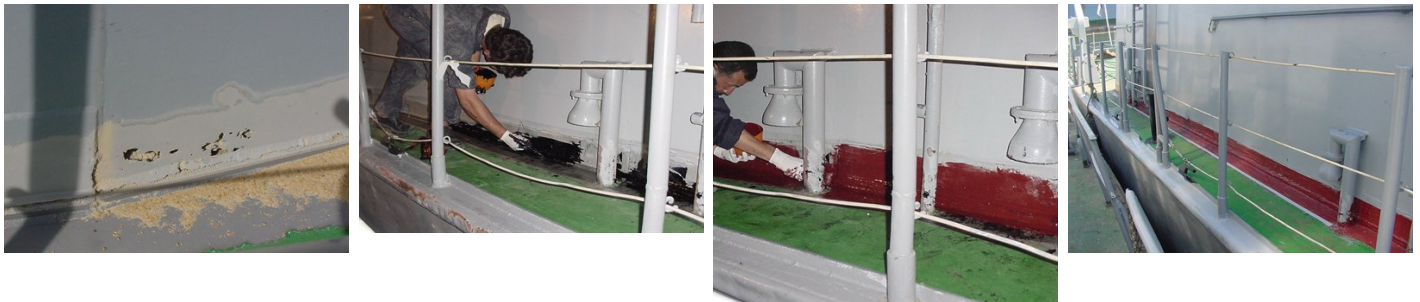
Corrosion in the joint between the deck and the upper structure of the vessel.

- * The corroded structure of the launch ,
- * Application of Belzona® 2111 ,
- * Belzona® 2121 coating was applied to seal the whole area ,
- * Launch ready for service ,

Belzona® 2111 was used to fill corroded areas. In this application a flexible repair material was needed due to the flexing of the launch. Belzona® 2121 was used to further protect the launch without welding the dissimilar metals.
