# Belzona Repairs to High Speed Vessel

Industry: *Marine*  
Application: *SOS-Ships and Offshore Structures*

Customer Location: *Ship repair company - Egypt*  
Application Date: *May 2002*

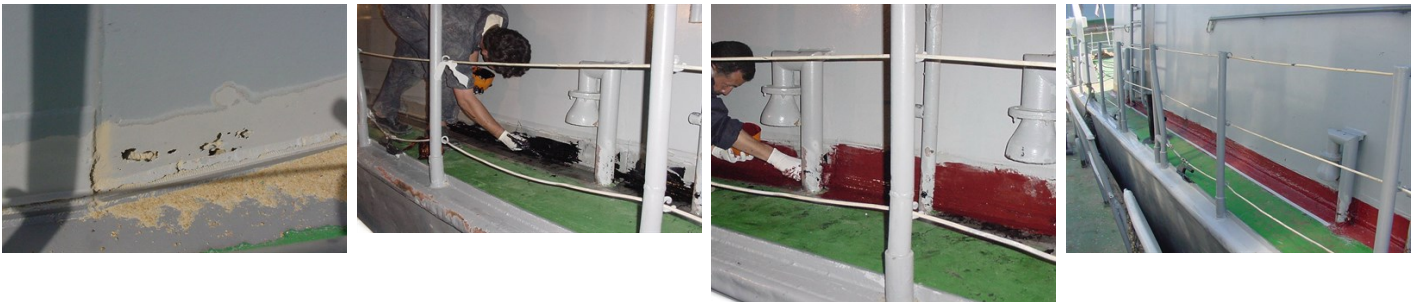
## Photograph Descriptions

*Corrosion in the joint between the deck and the upper structure of the vessel.*

- \* The corroded structure of the launch ,
- \* Application of Belzona® 2111 ,
- \* Belzona® 2121 coating was applied to seal the whole area ,
- \* Launch ready for service ,

Belzona® 2111 was used to fill corroded areas. In this application a flexible repair material was needed due to the flexing of the launch. Belzona® 2121 was used to further protect the launch without welding the dissimilar metals.
