# BELZONA REPAIRS DISCHARGE PIPES OF A CYCLONE FEED SUMP

ID: 5532

Customer Location: Mine, Bolivia

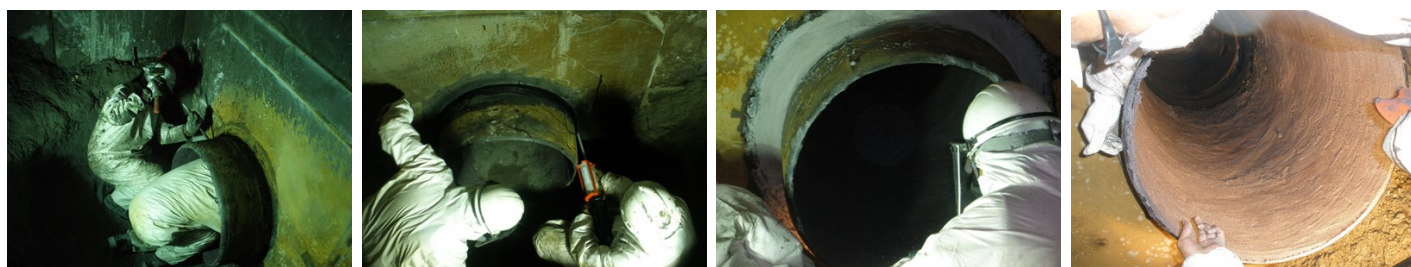
## Photograph Descriptions

Damage of concrete. Loosening of the discharge pipes of the cyclone feed sump, caused by impact. Wear in the interior of the ducts, due to ore abrasion.

- \* Preparation of the surface ,
- \* Injection of the Belzona 4151 to fill the space between the wall and the pipe ,
- \* Repair of damaged concrete with Belzona 4111 ,
- \* Belzona 1812 coating to protect against wear caused by abrasion. ,

The discharge pipes of the cyclone feed sump were loosened from the Concrete Wall due to impact and wear in the metallic structure caused by abrasion.

The application was carried out in accordance with Belzona Know-How System Leaflet FPA-10 for fastening the pipe to the cyclone feed sump wall, injecting Belzona 4151 and FPA-1 for rebuilding the concrete wall with Belzona 4111. SHM-8 for coating the interior and exterior of the pipe to protect against wear caused by abrasion.

maintenance. These pipes transport 1,400 tons of ore each day. To date, the pipe is perfectly adhered to the concrete. Belzona 1812 needs to be applied only to the bottom part of the pipe, since this is a sacrificial product.
