WATER REPELLENT BELZONA TREATMENT FOR SWIMMING POOL WALLS

Customer Location: Local Council Swimming Pool,
Gloucestershire, UK

Application: WPA-Wall Problem Areas

Application Date: February 2008

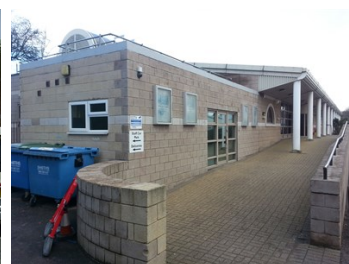
- * Concrete blocks stained with salt ,
- * Repair area lightly blasted ,
- * Application of Belzona 5122 ,
- * Application revisited after 7 years in service ,

work. Blasting was carried out before opening hours and the water repellent treatment was carried out in 2 stages to ensure minimum disruption to the public. The system has lasted the test of time for the council and they are more than happy with the results. No salts or staining on the concrete block walls is visible even after 7 years.
