BELZONA UPGRADES SAFETY OF STAIRS AT MULTI-STORY CAR PARK

ID: 5558

Application: FPA-Floor Problem Areas

Customer Location: Local Council, UK

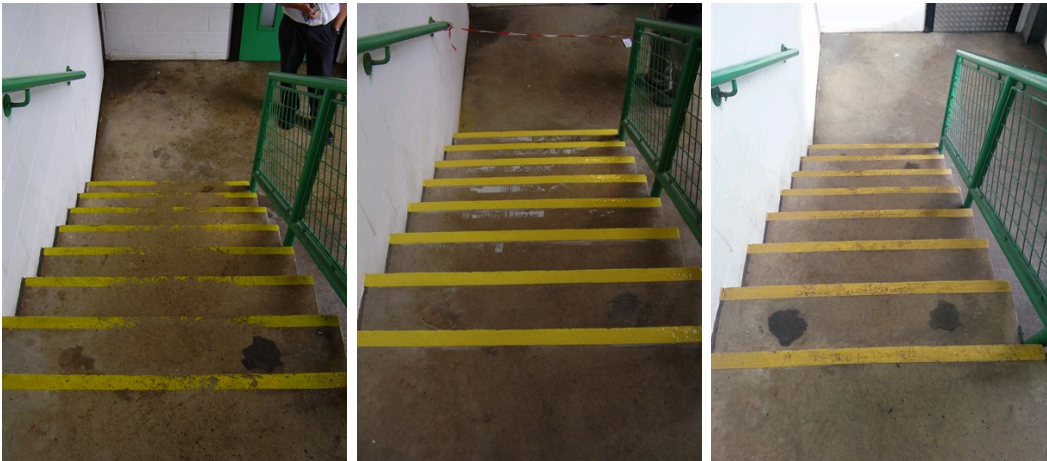
Photograph Descriptions

Steps presented a slip hazard to users of the car park.

- * Original painted grip system ,
- * Belzona 4411 grip system applied in 2008 ,
- * Application revisited in 2015 ,

Worn steps.

The application was carried out in accordance with Belzona Know-How System Leaflet FPA-8. Belzona 9221 was encapsulated in Belzona 4411 and applied in an even coat.

These stairs have been used by thousands of people over the last 7 years and they were shutting down these stairs every couple of

months to re-paint prior to the Belzona 4411 application.
