# BELZONA REPAIRS JACK HAMMER BASE IN PRIMARY CRUSHER

ID: 5559

Customer Location: *Mine, Carajás, Brazil*

Application Date: *July 2007*

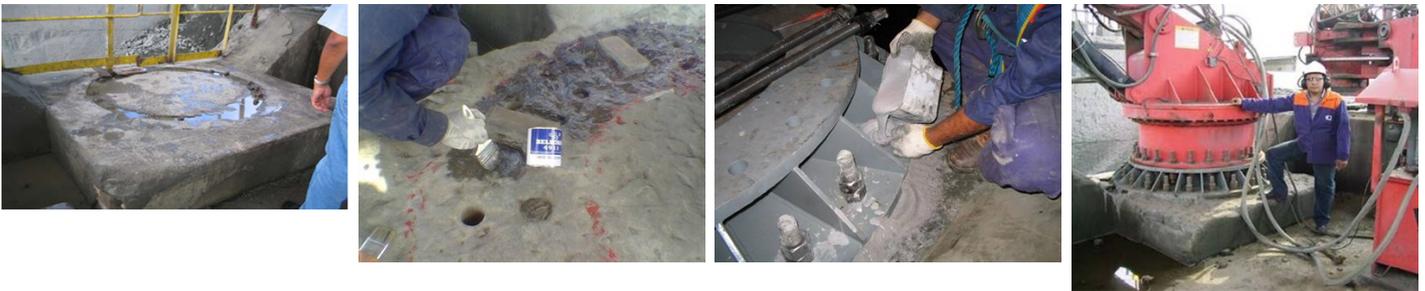
- \* Concrete base with the cut bolts ,
- \* Conditioning of the concrete base with Belzona 4911 ,
- \* Application of Belzona 4111 and Belzona 4151 at the installation of the bolts in the holes ,
- \* Repair of the base, completed ,

The bolts at the base of the jack hammer suffered from shear stress resulting in loosening of the base and possible fall from the equipment inside the hopper of the primary crusher.

Some holes were made with a diamond-tipped bit to a depth of 1,250 mm to install new bolts. The concrete base and the open holes were cleaned with soap and water to eliminate any residual oil or grease. The area was adequately dried and cleaned. Later Belzona 4911 was applied at the base of the concrete as well as in the open holes. The base was leveled with Belzona 4111, leaving an opening of 0.5 cm between the block and the base. After grit blasting the metal to a near white finish, the surface was cleaned and conditioned, the base of the jackhammer and the bolts were installed over the base. Belzona 4111 and Belzona 4151 were applied in the housing of the bolt and were injected between the concrete base and the other metallic base of the jack hammer.

The repair with Belzona allowed the equipment to return to service without needing demolition of the existing concrete base; which would have caused a longer downtime and greater repair cost.
