BELZONA STOPS LEAK IN A HYDROPOWER PLANT

ID: 5560

Customer Location: Hydropower Plant, S.E. Washington, USA
Application Date: February 2015

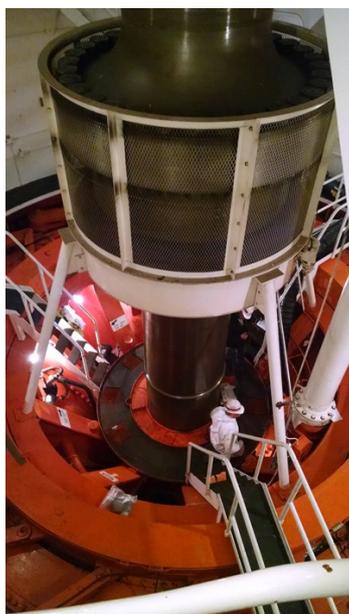
Weld failure at the bottom of the reservoir resulting in an active oil leak, creating a hazard as well as potential ecological contamination.

- * Inside the powerhouse. ,
- * Inside the turbine housing. ,
- * Active leak. ,
- * Completed application. ,

Oil sump reservoir in the bottom of a turbine in a hydro dam.

The existing paint had already been removed to identify the source of the leak. The surrounding surface was properly cleaned and roughened by hand with emery paper. Located at the bottom of a 3' tall reservoir, there was gravitational pressure resulting in a low pressure, slow leak. Using Belzona 1212, an oil tolerant, fast curing material, a small steel plate was bonded over the leak. A second plate was also bonded in a second layer over the repair location to ensure success.
