# BELZONA SAVES TIME IN A BATTERY STATION

**Industry:** General Industry  
**Application:** FPA-Floor Problem Areas  
**Substrate:** Concrete  
**Products:** \* Belzona 4131 (Magma-Screed) ,  
\* Belzona 5811 (Immersion Grade) ,

**Customer Location:** Duncan, Oklahoma, USA  
**Application Date:** February 2015

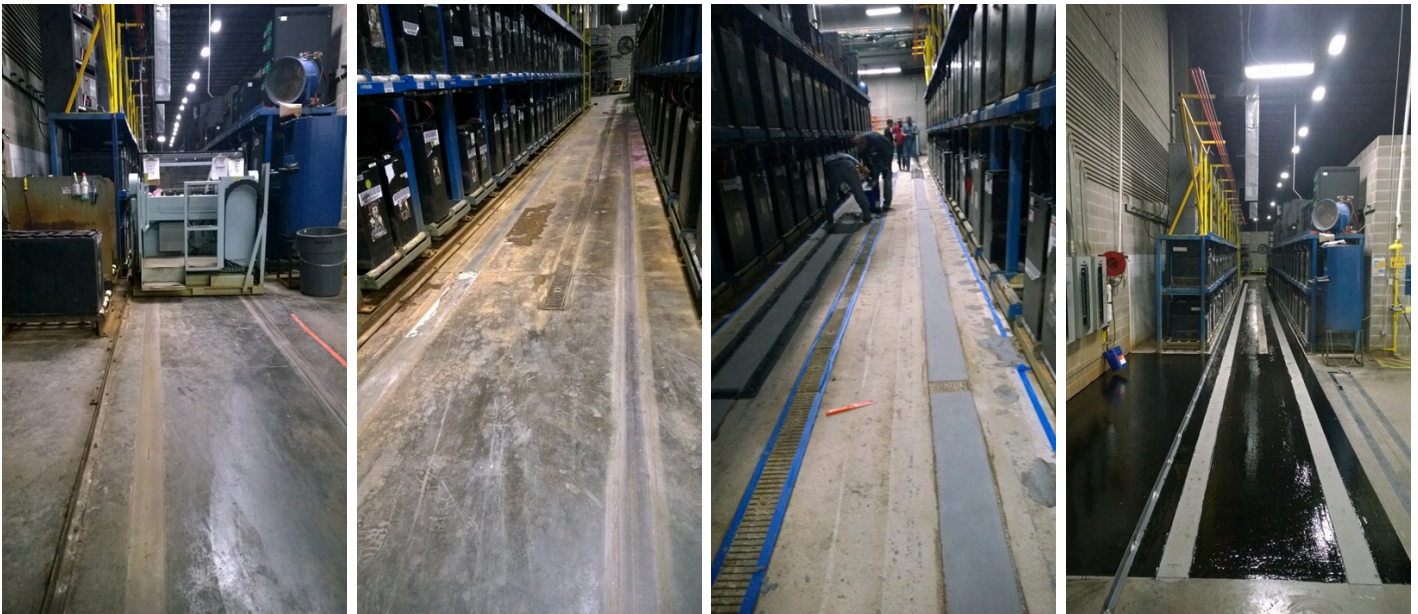
The main path for the current battery forklift was worn to the point where the lift could no longer be used to exchange charged batteries onto the forklifts. The worn pathways were 1/2" to 3/4" deep and 6" wide from the existing elevation. Due to extreme wear from the battery forklift and acid spills on concrete, the 6" wheels had created ruts in the existing concrete, causing damage to the battery forklift that required monthly repairs. The objective was to rebuild 8" wide runways for the battery forklift and provide a protective coating for the Battery acid from runways.

- \* Battery forklift in place ,
- \* Battery forklift removed; full view of battery station ,
- \* 8" battery forklift runways being rebuilt with Belzona 4131 ,
- \* Completed project before battery forklift was reinstalled ,

The worn battery forklift runways were widened and rebuilt with Belzona 4131 and the surrounding concrete substrate was coated with Belzona 5811 to prevent further battery acid corrosion to concrete. Other products were used to rebuild track runways but quickly failed. The traditional repair option was to cut out concrete and replace. The repair estimated to cost an average of \$75,000 and take 28 plus days of shutdown. Note: the cost wasn't the issue as much as the downtime. The Belzona solution provided a cost savings of \$58,000 and reduced downtime by 25 days when compared to the traditional repair method. Actual downtime: this project was completed on a scheduled weekend shutdown for other repairs within the facility.
