# BELZONA 1523/1593 HELP COMBAT CORROSION WITHIN AN AMMONIA ACID GAS KOD

ID: 5566

Application: TCC-Tanks and Chemical Containment Areas

Application Date: January 2014

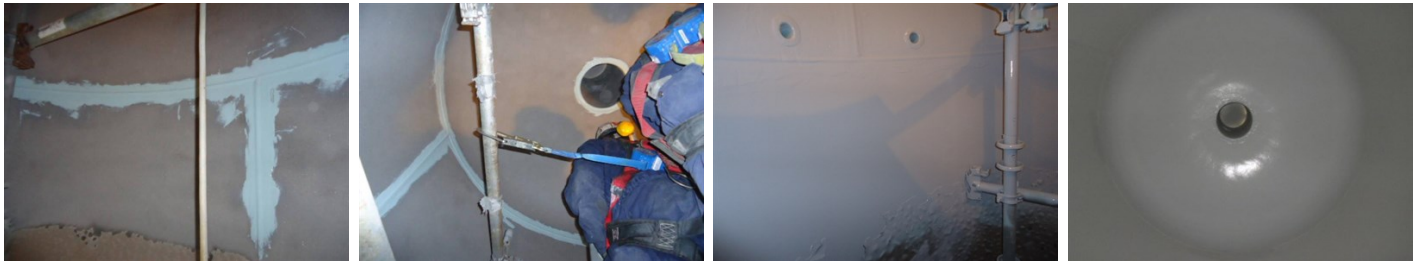
## Photograph Descriptions

- \* The surface was prepared by blasting to SSPC SP-10 Near White Metal ,
- \* Stripe coating of welds and sharp angles with Belzona 1593 ,
- \* Application of the 2nd coat of Belzona 1523 in light grey ,
- \* Complete application ,

Ammonia acid gas knock-out drum (KOD) operating at 250°F and suffering from corrosion due to exposure to a mixture of hydrocarbons consisting of C1-C5, nitrogen, ammonia, water, and wet carbon dioxide.

The application was carried out in accordance with Belzona Know-How System Leaflet TCC-5. After grit blasting to SSPC-SP 10, the surface was Bresle tested for salt soluble contaminants, cleaned, and degreased with Belzona 9111. Due to high levels of relative humidity, a dehumidifier unit was utilized to prevent flash rusting of the prepared surface, thus avoiding any risk of corrosion prior to coating. Following this, Belzona 1593 hand applied lining was used for stripe coating and nozzle lining. The crew continued with the application of Belzona 1523 using a plural component Graco airless spray system. The coating was applied as a two-coat system

with contrasting colors. The application was reported to be a success and the material was found to "spray beautifully". Coating was allowed to cure for inspection. High voltage test was conducted and spotted pinholes were repaired accordingly using Belzona 1593.
