BELZONA 1212 REPAIRS CRACKED TRANSFORMER FIN

Customer Location: Electricity Substation, Washington, USA
Application Date: March 2015

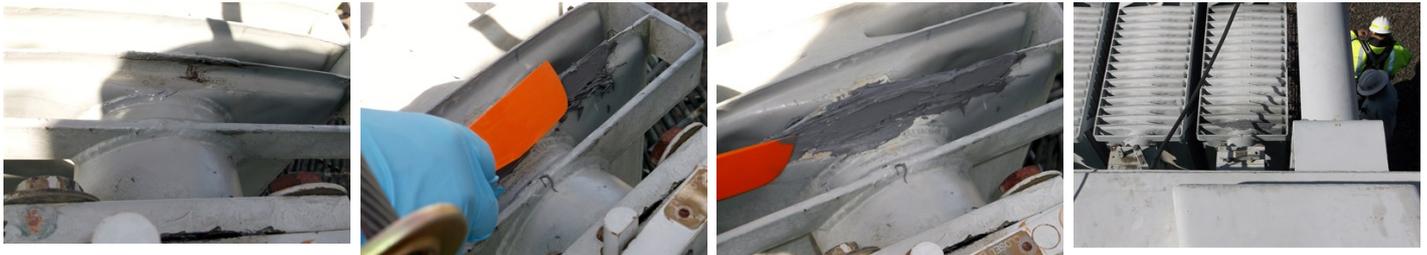
Photograph Descriptions

There was a crack on the top edge of the oil filled transformer radiator fin.

- * Crack with oil present. ,
- * Applying Belzona 1212. ,
- * Finishing application. ,
- * Completed application. ,

The application was carried out in accordance with a modified Belzona Know-How System Leaflet TCC-1. The paint was removed and the area was prepped with coarse emery cloth. Belzona 1212 was mixed per IFU guidelines and applied with a spatula, firmly pressing down to fill the crack and ensure maximum contact with the surface.

The first repair attempt to weld the crack actually developed a new crack next to the weld. This was an active leak, resulting in oil and nitrogen escaping from the transformer. With welding, the problem was only getting worse. The other option would have been to continue welding and possibly needing to drain the oil from the tank, removing the transformer from service for an extensive amount of time. Belzona 1212 allowed for a quick prep and a quick application with a fast cure time. Approximately 1/4 of a unit
